8-10-2015

Sartell Community Center Project

Executive Site Analysis Summary

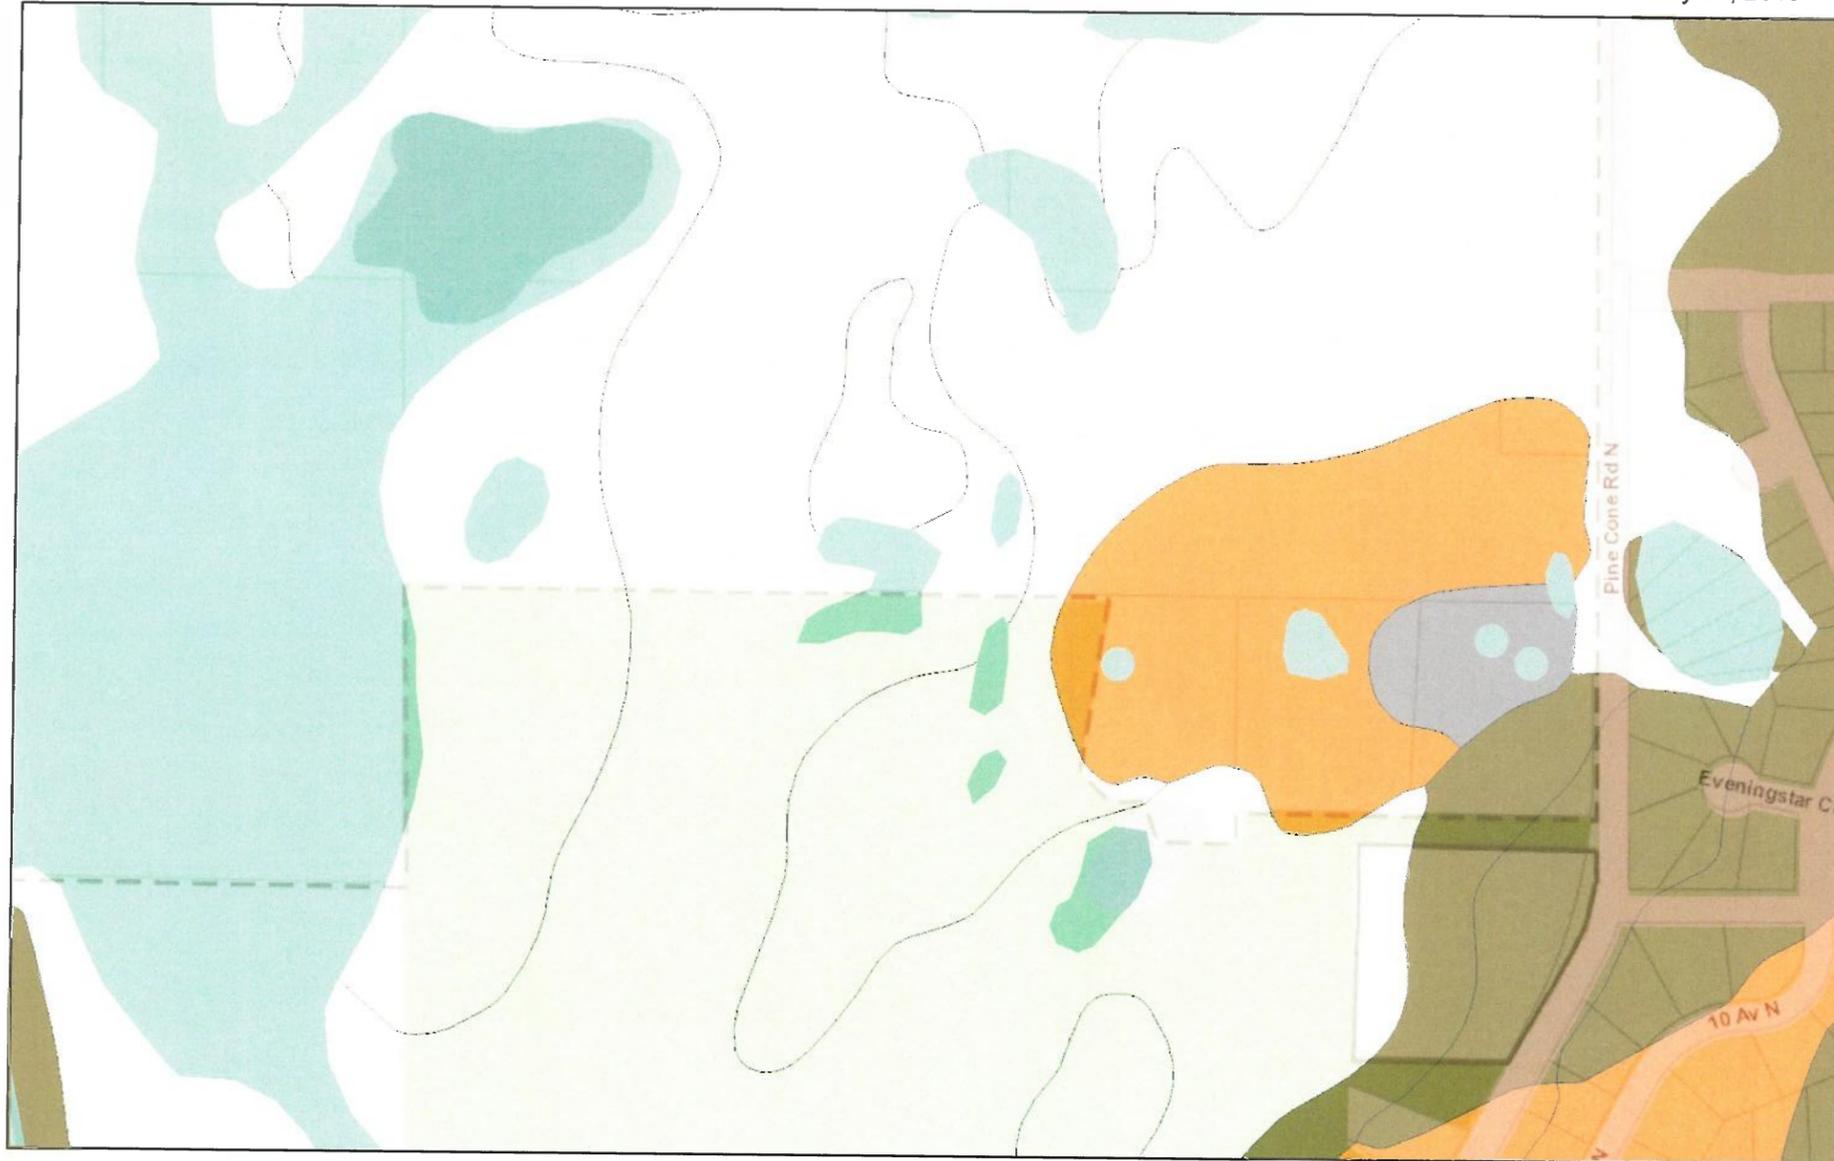
Villcheck Soils

- A: These soils have high infiltration rates when thoroughly wetted.

B: These soils have moderate infiltration rates.

C: These soils have slow infiltration rates.

D: These soils have very slow infiltration rates.

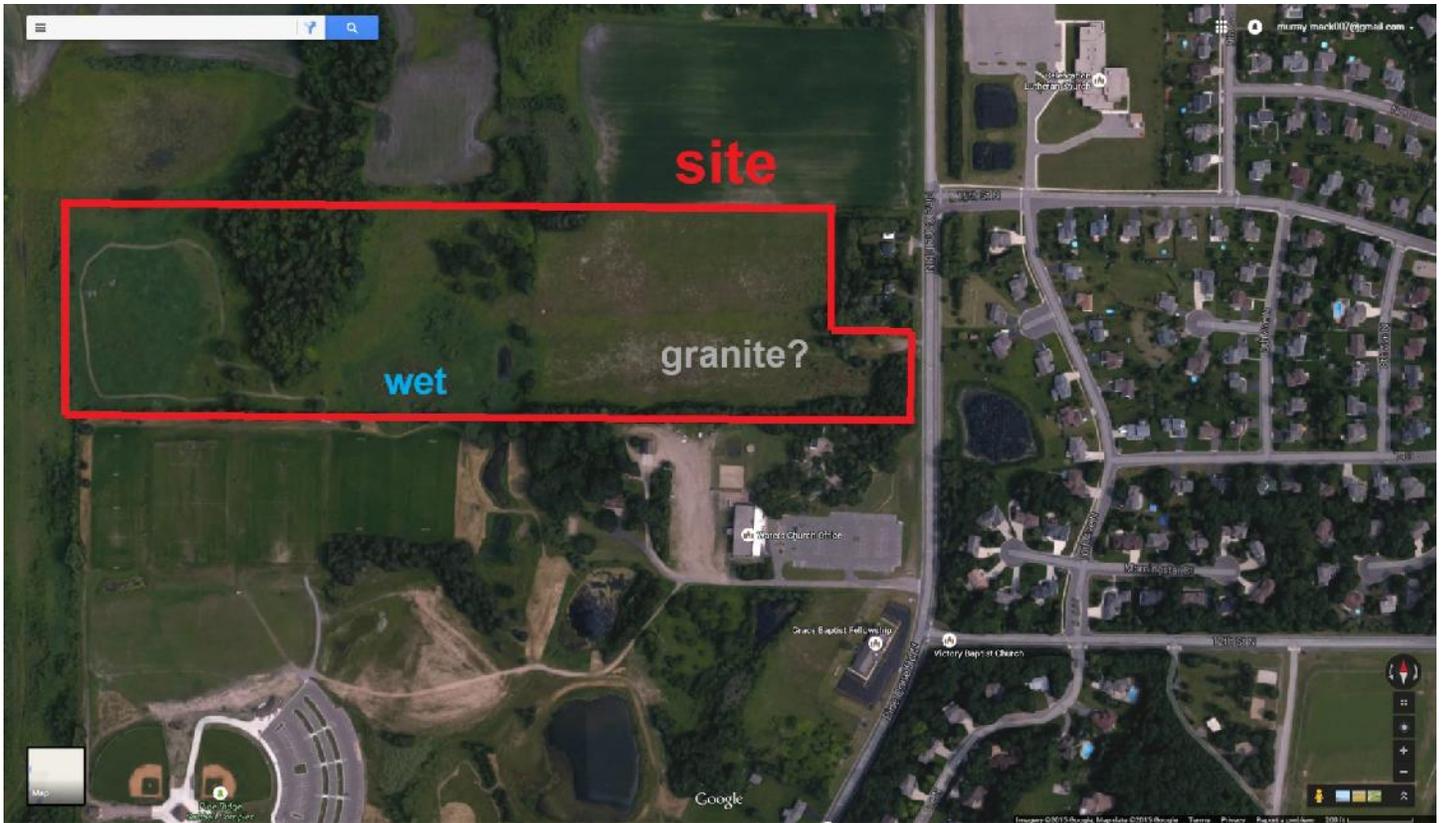
Villcheck Site:

The Villcheck site is a City owned site located on the north end of Sartell. The site is directly west of Pine Cone Road near 15th Street North. The site was originally purchased with the idea that this site could be an extension of the Pinecone Central Park which would accommodate additional recreations fields, parking etc. The site is rectangular in nature and contains approximately 38 acres of land. This report assumes development of the eastern half which would provide approximately 20 acres of property. The site was previously considered for a housing project which for reasons unknown for this report, was abandoned.

The site is generally flat with some contour to low areas. The site is considered marginal in soils types with wetlands in the south/center part of the site and wet soils to the west. Some granite outcroppings have been noted throughout the site and could pose a problem with the installation of utilities and footing/foundations. It is not anticipated that a basement will be part of the building design but if so, the water table would be of some concern. Soil borings would be highly recommended before proceeding with additional consideration of this site.

Based upon the above noted soil concerns and a connection to Pine Cone, it is highly likely that the best building site would be on the eastern half of the site. Access would most likely be limited to the 15th Street intersection. It is anticipated that 15th would have to be extended approximately 660' to the west along the eastern half of the site to provide access directly into the parking/building area. It should be noted that Pine Cone Road north of 15th Street is currently not up to urban standards and has no trails. Also, the City may need to advance the improvements on Pinecone Road and complete the extension of 15th street from Pine Cone Road to 19th Avenue. Sewer and water would be extended from the west trunk line and would have to

The building program will fit on the eastern portion of the site as shown on the schematic site plans. It is somewhat restrictive north to south. Because the community center would be accessed from an extension of 15th, the parking and entry would "typically" face north. That is not a desirable orientation. If a south facing entry and parking lot is desirable a driveway could circulate around the building to provide such an orientation. While this is good for natural light and winter conditions, it would create challenges to first impressions and building aesthetics as you enter the site. An east facing entry is also a viable option. It appears that there are some opportunities for nice views to the north and to the west. There could be some challenges at least in the winter to the views directly south to the industrial use of the adjacent business.

The site is not very visible with the two single family residences and the trees to the south blocking views into the site from the south. From the north the site is reasonably visible at least until development of the property to the north occurs.

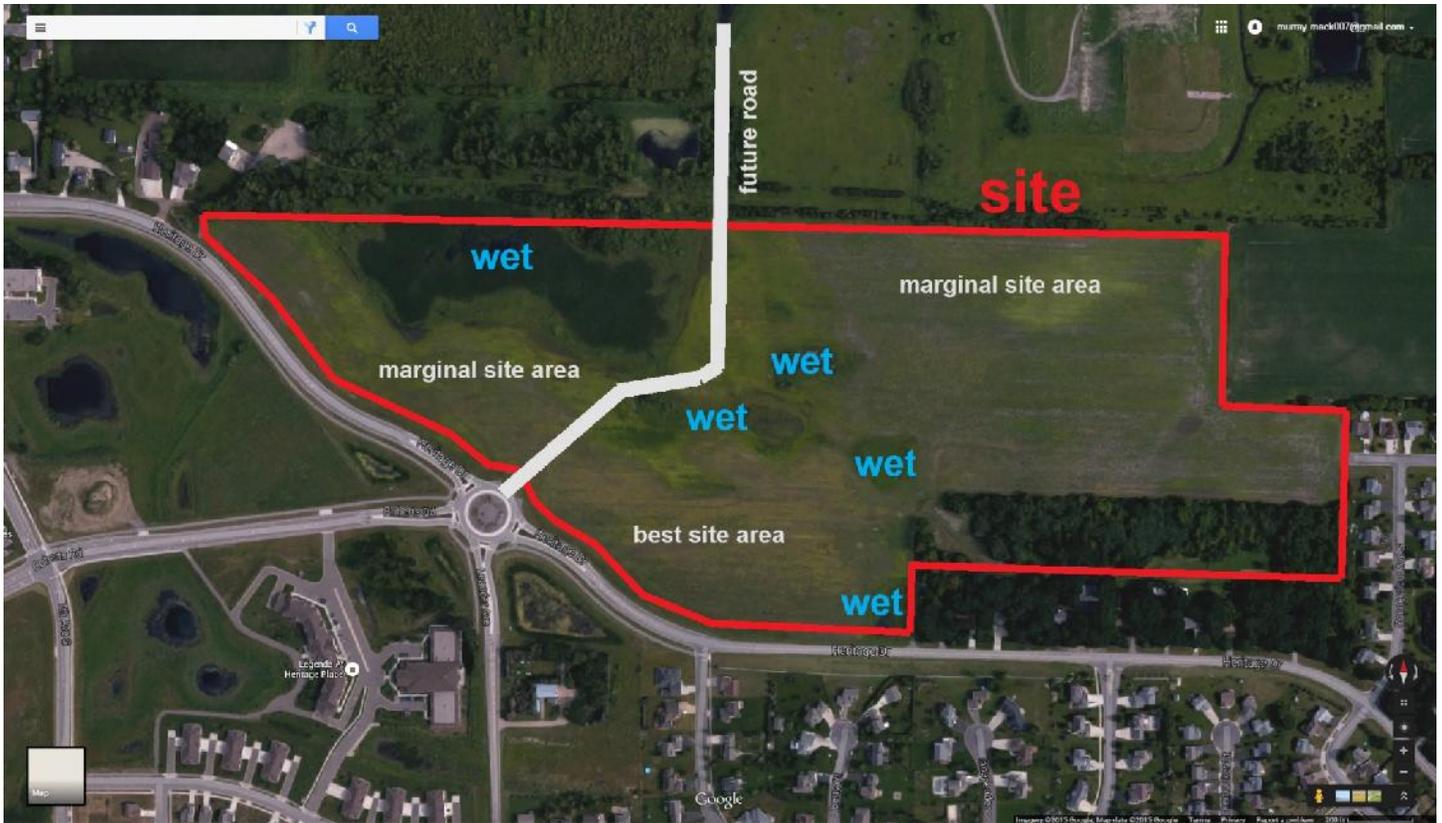
Heritage Site:

The Heritage site is a City owned site located north of Heritage Drive near the roundabout at Robert's and Leander. The site is generally rectangular in nature and contains approximately 71 acres of land. This report assumes development of the southern section of the property directly north of Huntington Drive South. The site was previously considered for a housing project which for reasons unknown for this report, was abandoned. The City subsequently acquired the property through tax forfeiture.

The site is considered marginal in soil types with wetlands in the center part of the site and wet soils to the west. It is not anticipated that a basement will be part of the building design but if so, a high water table would be of some concern. Soil borings would be highly recommended before proceeding with additional consideration of this site. Until a survey would be completed there is some additional concern regarding the overall topography in relation to Heritage Drive. The site could be considered "low" in comparison to Heritage which may require additional soil importing which could add to site costs. Additionally, it is anticipated that the elevation of the future 4th Avenue extension will be raised relative to grade. With both Heritage and 4th elevated as compared to the adjacent grade, significant fill may be required to accommodate the building and parking developments area.

Based upon the above noted soil concerns and a connection to Heritage Drive, it is highly likely that the best building site would be on the southern half of the site. Access would most likely come from a new road extending to the north as the 5th leg of the existing roundabout. It is anticipated that this road (4th Avenue) will be extended in 2016 (aggressive) or 2017 at the latest. Access to the site would have to be approximately 600'-700' north of the roundabout before an access point to the community center site could be introduced. It's possible the road could dead end until the extension to 4th is completed. It's possible although not recommended that another southern access point could be introduced at Huntington. Sewer and water would

The building program will fit on the southern portion of the site as shown on the schematic site plans. As noted above the site is somewhat restrictive to the north and west. The best location appears to be just north of Heritage and east of the roundabout. This location would work well in the development of a south facing entrance and glazing area that would present well to Heritage Drive. A west or southwest orientation would provide some advantages relative to access from 4th as well as the aesthetics in that direction. Views to the west, north and east include trees and to the north some minor rolling hills. Views to the north could change over time with future development. The site is very visible from Heritage as well as the future 4th Avenue.

Heritage site showing two site options. The NW option is too close to wetlands with limited expansion. The SE option shows a SW orientation with an access approximately 600' north of the existing roundabout and a possible access point from Heritage at Huntington. The Wet areas to the north and east could be expanded for on-site ponding. As noted previously, the site area may require significant fill in order to rise to, or above, the level of Heritage Road and the future 4th Ave. extension

Heritage site showing a southern orientation with an access approximately 600' north of the existing roundabout and a possible access point from Heritage at Huntington. The Wet areas to the north and east could be expanded for on-site ponding. As noted previously, the site area may require significant fill in order to rise to, or above, the level of Heritage Road and the future 4th Ave. extension.

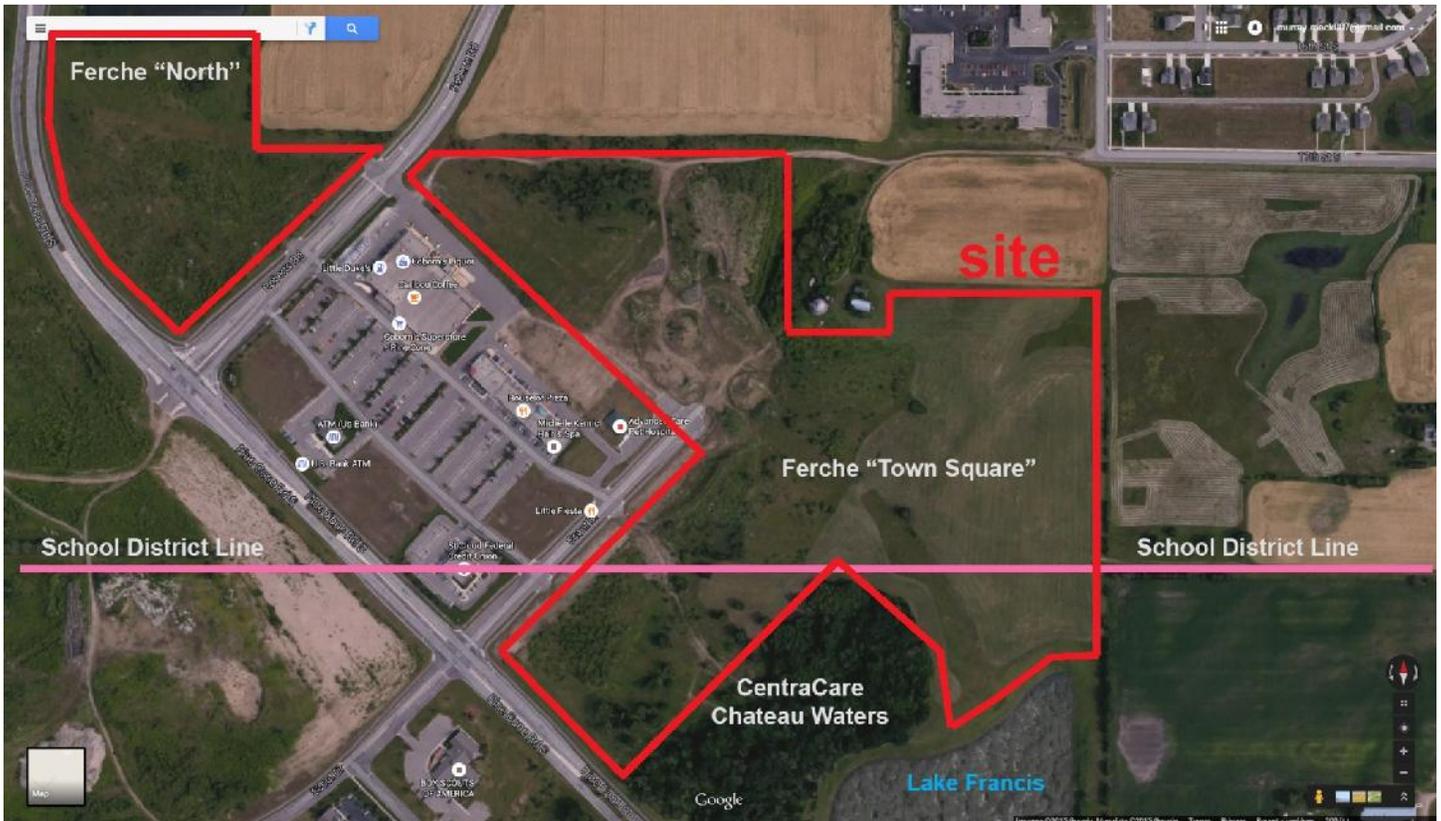
Ferche “North” & “Town Square” Site:

The Ferche sites are comprised of Ferche “North” and Ferche “Town Square” and are part of what is known as the Ferche 600. This property currently is currently owned by the Ferche Family. The Ferche “North” site is located on the NE corner of the intersection of Pine Cone Road and Roberts Road and would be defined on the north by the existing stormwater pond.

Both sites are considered to be good soil types for construction. Based on work at the Chateau Waters and the Coborn’s development it is not anticipated that any significant soils conditions would be encountered. Again,

soil borings would be highly recommended before proceeding with additional consideration of either site once a more defined site area is established. Topography is generally flat with some general slope over larger areas depending on location. The Ferche "North" site is actually high relative to Pine Cone and Roberts which will provide some advantages relative to cut/fill, drainage and building visibility. There are existing stock piles of earth on the Town Square site area that would have to be moved or used if locating the site in that area. From an aesthetic standpoint, the removal of these stock piles would be desirable if the project were located anywhere within the Town Square site area.

Access would likely come from the west from an extension of Scout Drive to the east. It is anticipated that a new roundabout will be installed at the intersection of Scout and Pine Cone Road this year. This roundabout will help facilitate access to Pine Cone for development within this area. Future access points could come from 17 Street South to the north and from an extension of Dehler to the east. As noted above, actual road configurations will be critical to establishing future development plots around the community center site. Utilities are available at Scout Drive and would be extended east as needed to connect with the site. If the site were located further north, utilities may come from an extension of 17th or from Roberts.

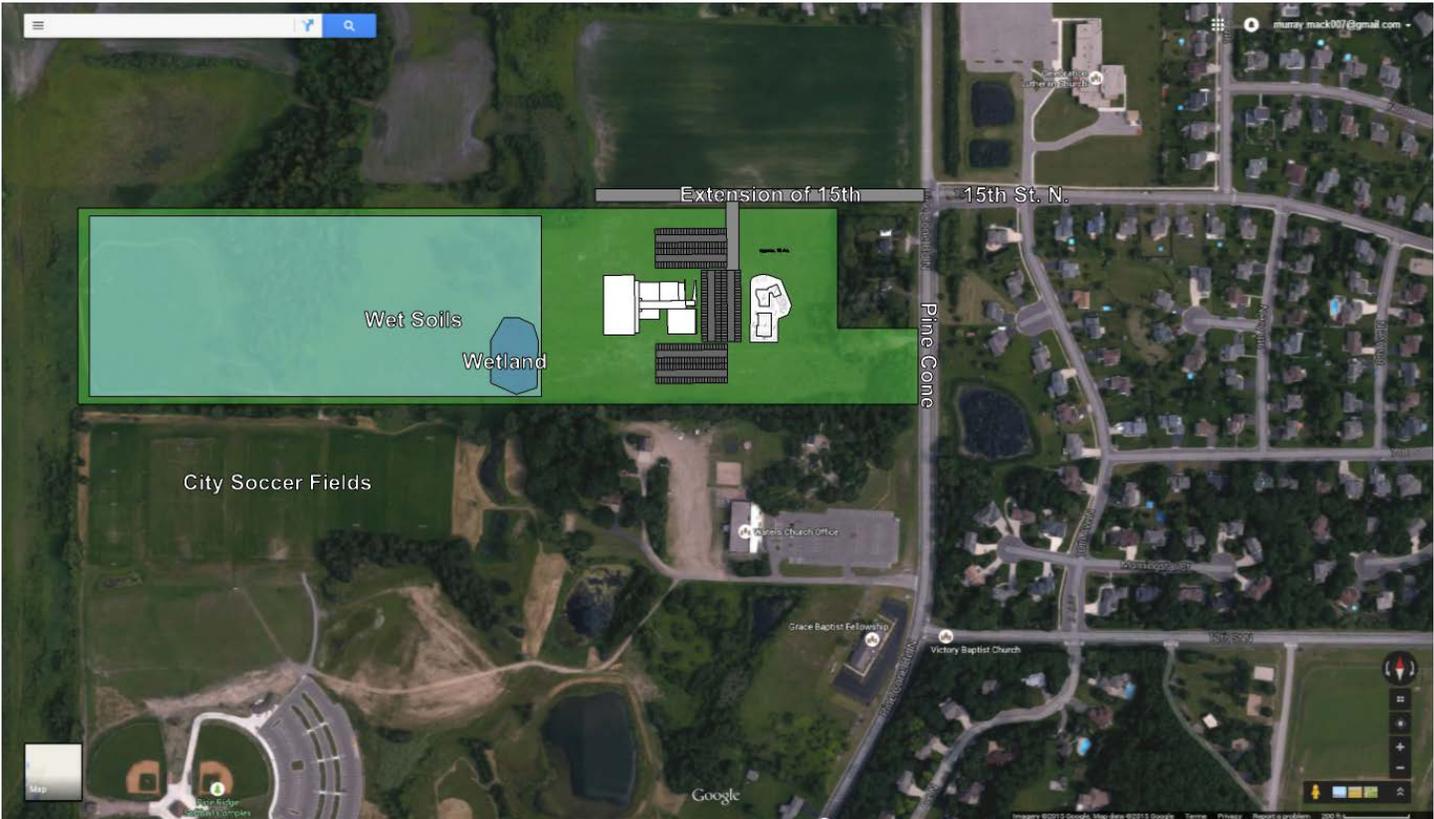
Villcheck site showing a north access from extended 15th Street N. with an east orientation. Note concern of visibility to the facility from Pine Cone.

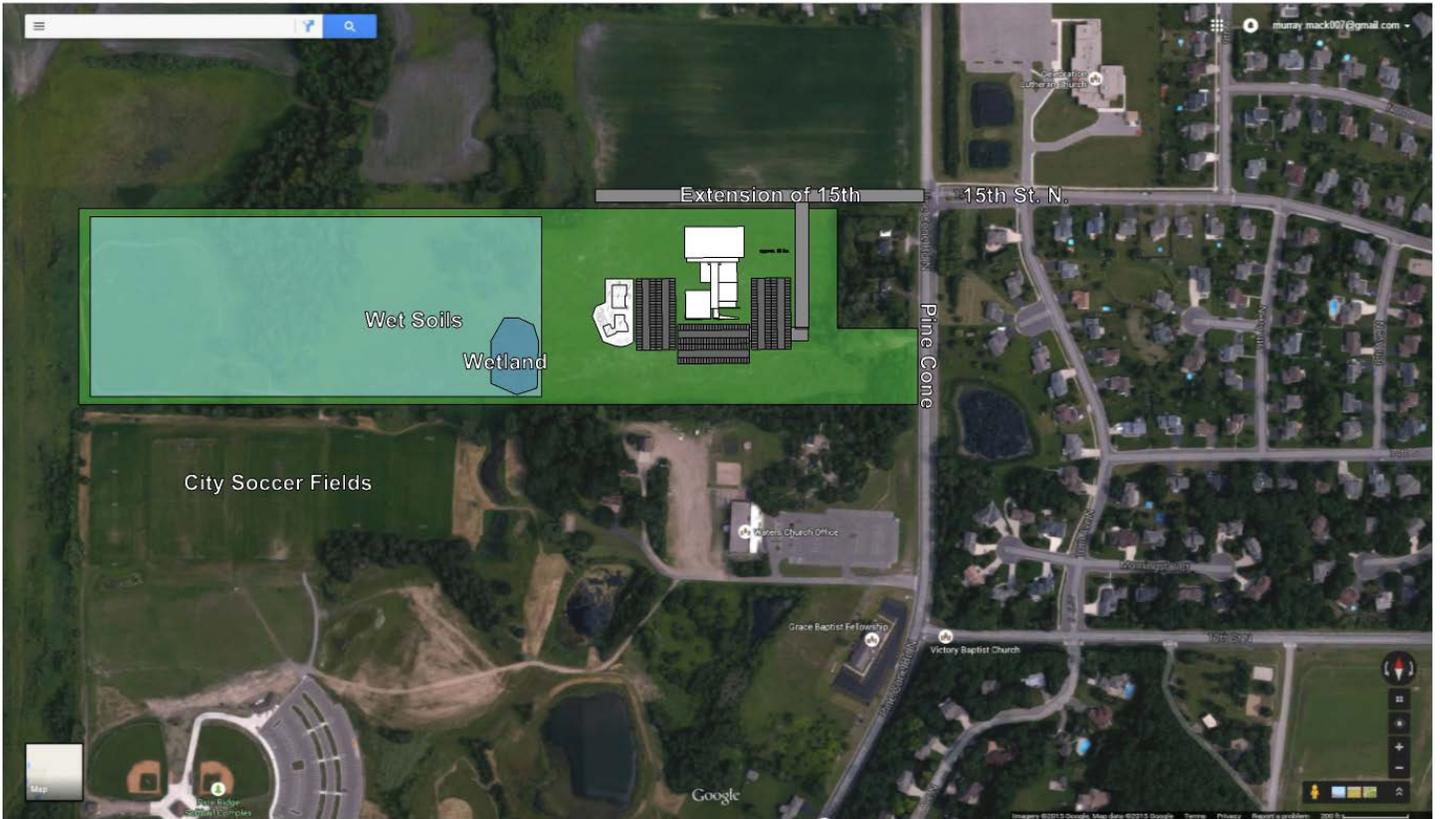
Villcheck site showing a south orientation. Note concern of visibility to the facility from Pine Cone. Additionally some concern over views to the south toward the industrial type development.

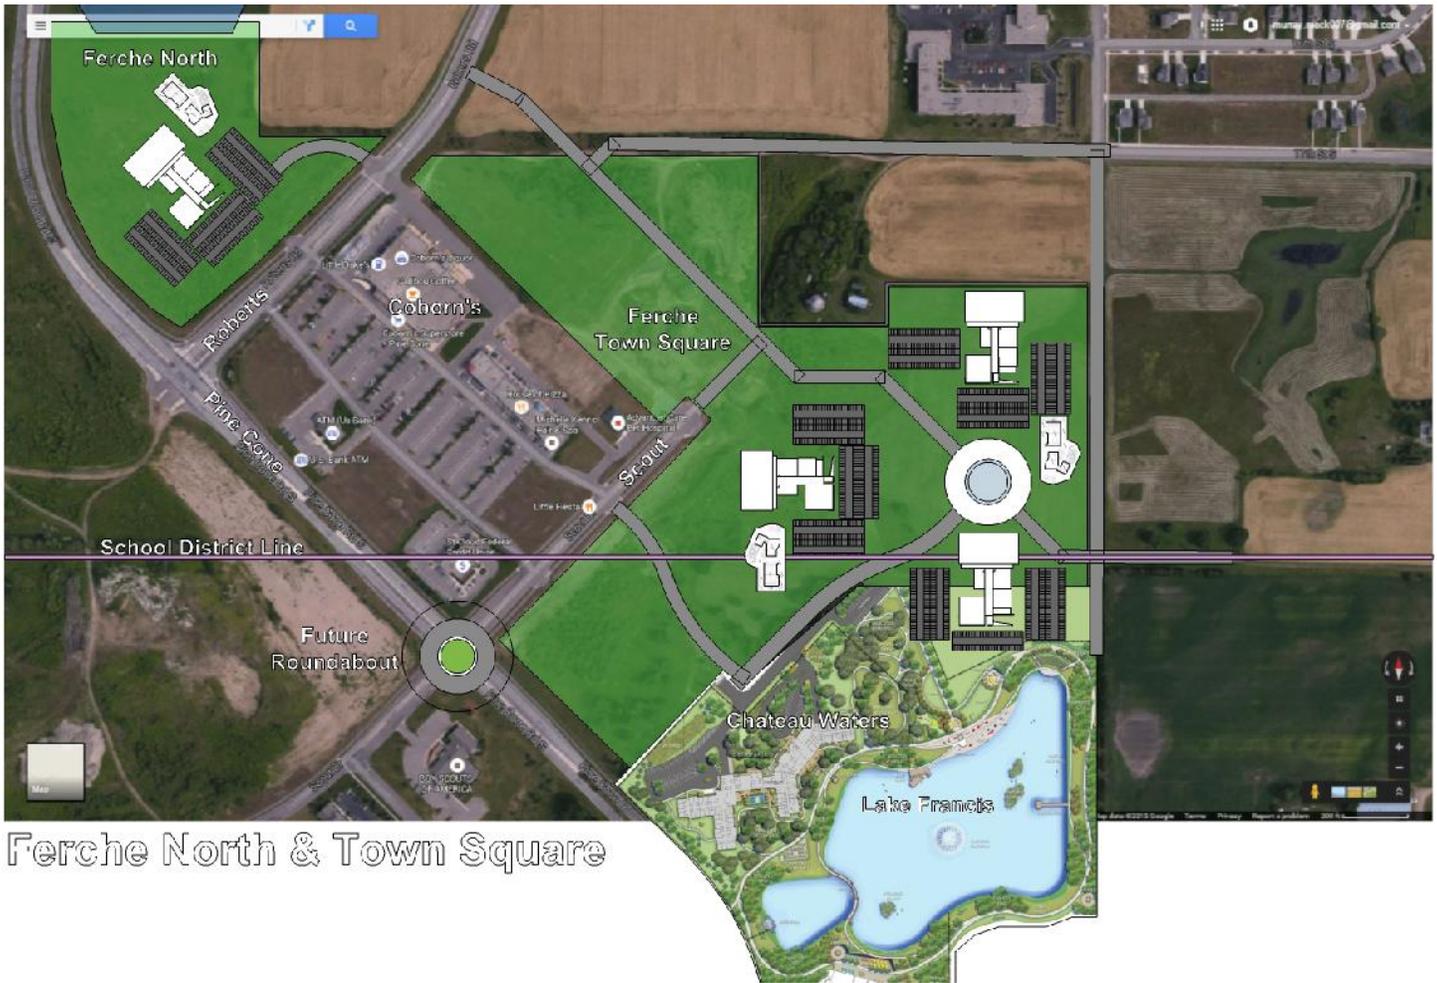
Ferche North & Town Square

Ferche North and the Town Square area:

The western Town Square location would facilitate a closer connection to Scout and utilities. The entry orientation may shift to the west to better facilitate that connection.

The northern Town Square site is a bit tight based on the roads shown but could be increased with adjustments to the proposed roads. Orientation would be to the south or west.

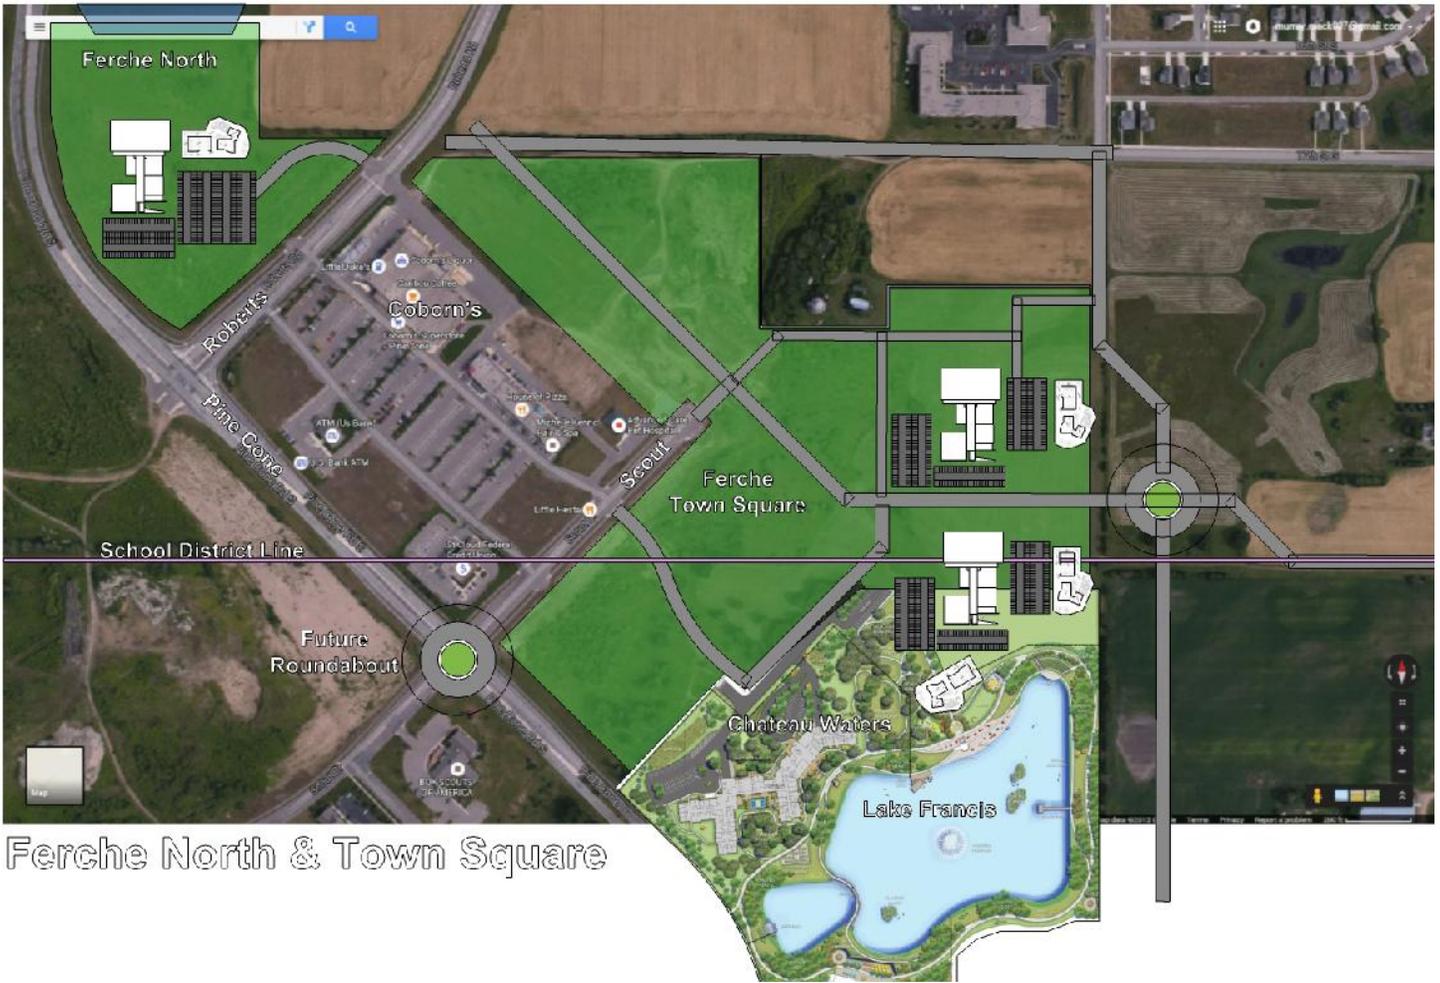
Ferche North & Town Square

Ferche North and the Town Square area:

The Ferche Town Square area shows a possible road configuration among many that may be possible where the proposed roundabout from the first scheme is moved east and connects more directly with Dehler and 7th. This would provide more buildable area directly in the central Town Square area and more flexibility in project location.

Further discussion and analysis should be conducted on options for the roadway configuration and how a masterplan for the roads can accommodate the Sartell Community Center, Town Square and overall traffic patterns in this area.

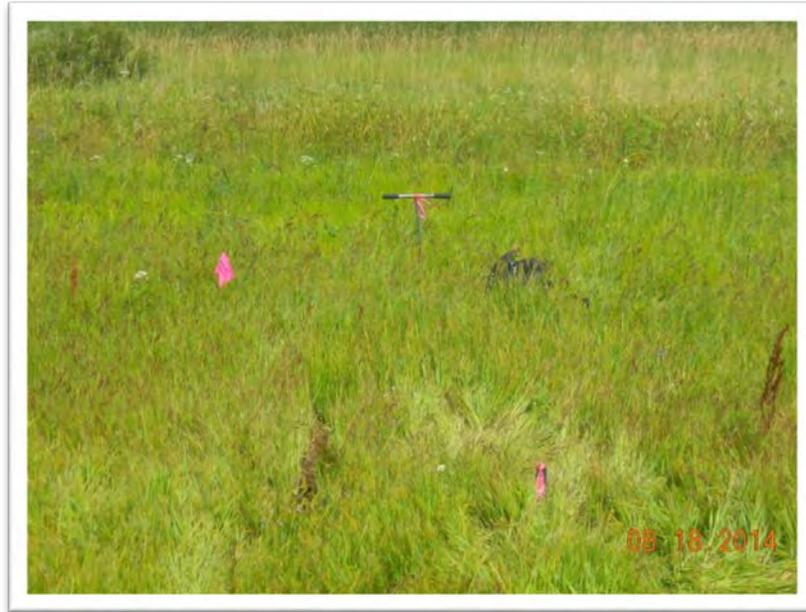
Photo #1: Wetland A, transect 1, with the soil auger showing the wetland point and pink tape in the foreground showing the upland point, facing north.

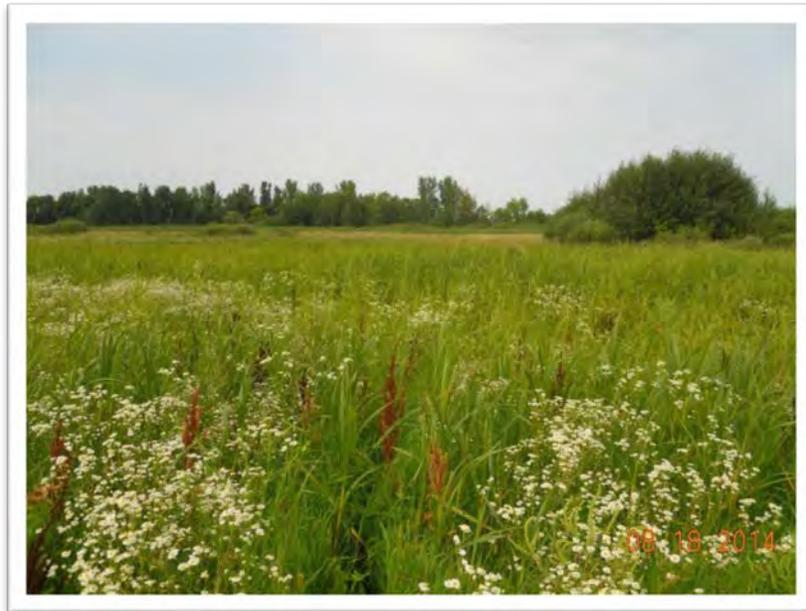
Photo #2: Wetland A, transect 2, with auger showing the wetland point and prairie fleabane indicating the transition to upland, facing north.

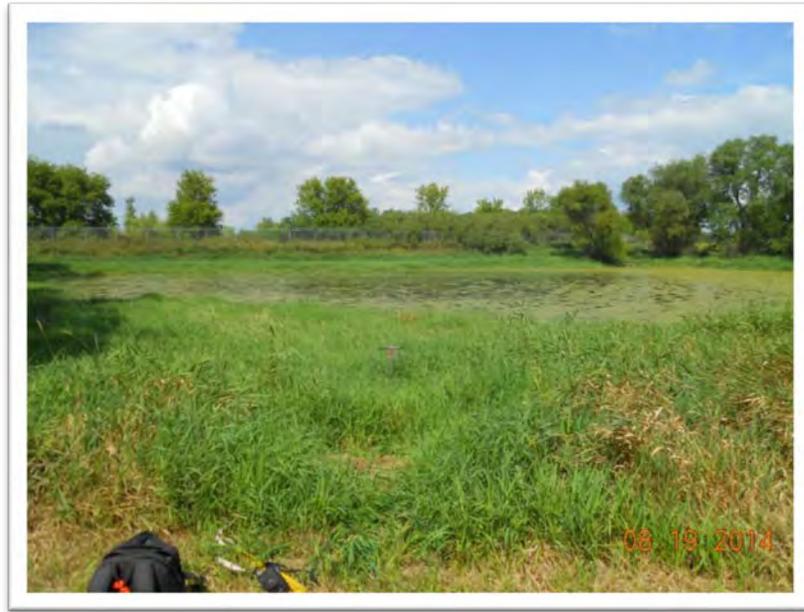
Photo #3: Wetland B, transect 1, with auger in the background showing the wetland point and the pink flag in the foreground showing the upland point, facing north.

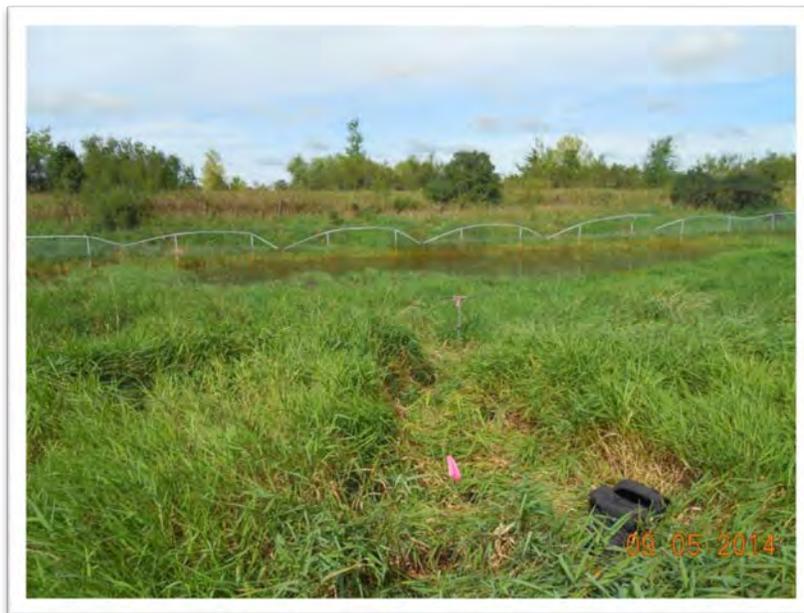
Photo #4: Wetland C, transect 1, with auger showing wetland point and pink flag in foreground showing upland point, facing northwest.

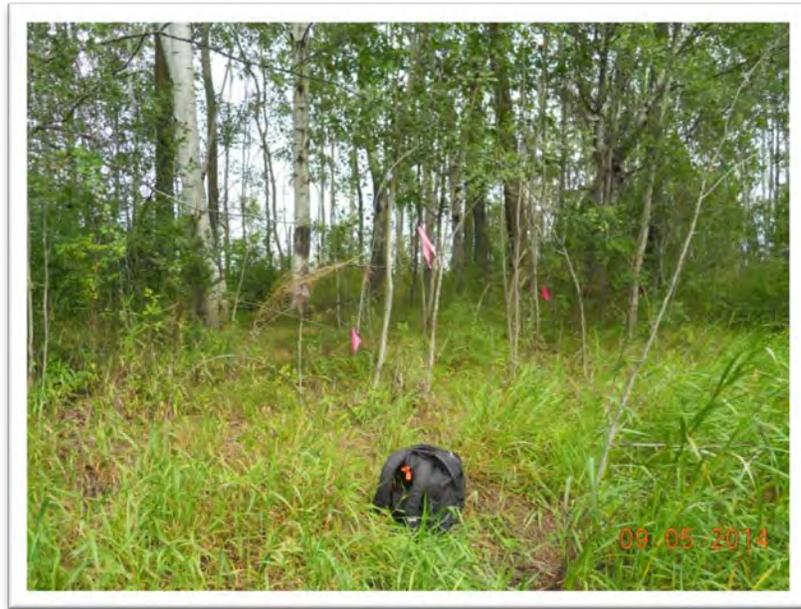
Photo #5: Wetland D, transect 1, with auger showing upland point in background and backpack indicating wetland point in foreground.

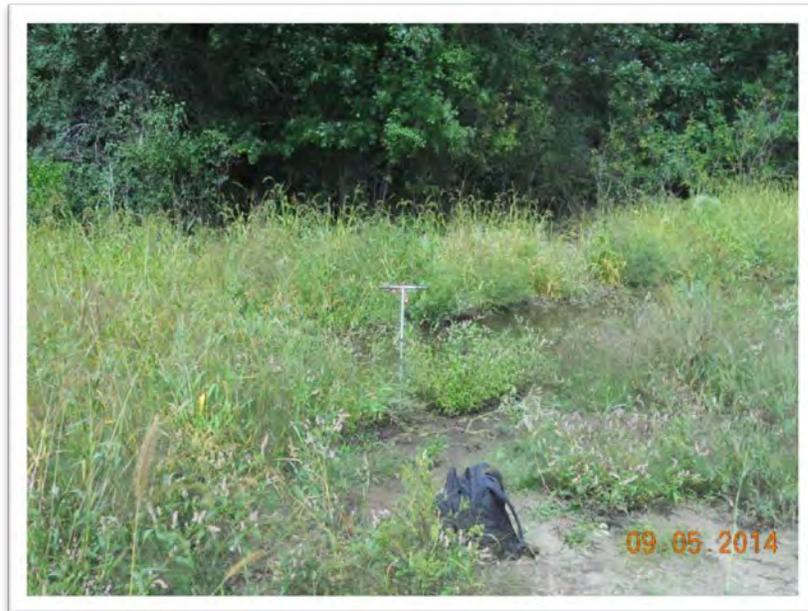
Photo #6: Sample Point E, indicated by soil auger, facing north.
